Multi-Zone Cathodic Protection Monitoring for Bridge Applications

Jamey Hilleary
Elecsys Corporation
846 North Mart-Way Ct.
Olathe, Kansas 66061
USA

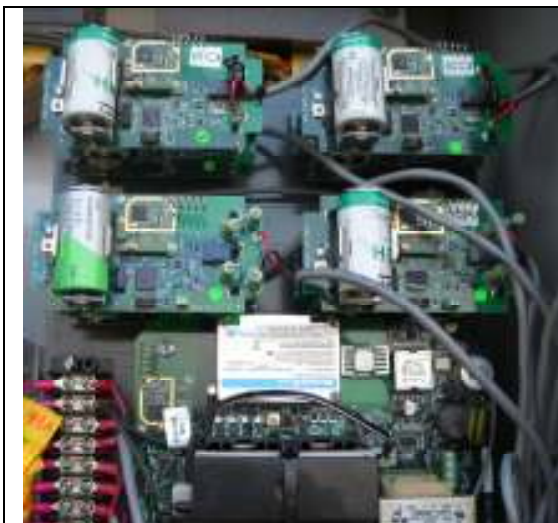
Figure 1: Base station with eight measurement modules close up view.

The site selected for the pilot installation was a north-south highway overpass on a city belt interstate highway at a significant east-west interchange. The site included two, two-lane overpass bridges divided into four cathodic protection zones. Each zone is associated with a discrete, dedicated rectifier, and all the rectifiers at the site are housed in a single enclosure. The operational readings required from each rectifier were the output voltage, output current, and structure to reference cell voltage potential for each zone. System design factors considered in this project were available space for system deployment, and the ongoing operational and communication costs of the system. Typical available monitoring systems would require multiple devices being deployed at each location due to the input channel limitations of the monitor devices. The solution decided upon used a single communication device (base station) with the capability to receive measurement values from discrete analog measurement devices (modules). Each base station device was configured to communicate with up to sixteen modules using a low power, mesh network, wireless communication protocol. This design allowed a single communication device to transmit the operational values for up to five zones at any given site, incurring a single communication cost. It also allowed for each system to be scaled for the measurement requirements specific to each site location. The system components were mounted on a single panel for installation inside the rectifier enclosure (Figures 1 and 2). Available space required the measurement modules be stacked in pairs, limiting access to the bottom modules. Additionally, the 4 modules used to measure structure to reference potentials were mounted at the bottom of the rectifier enclosure, away from the rest of the system. This was also due to limited space

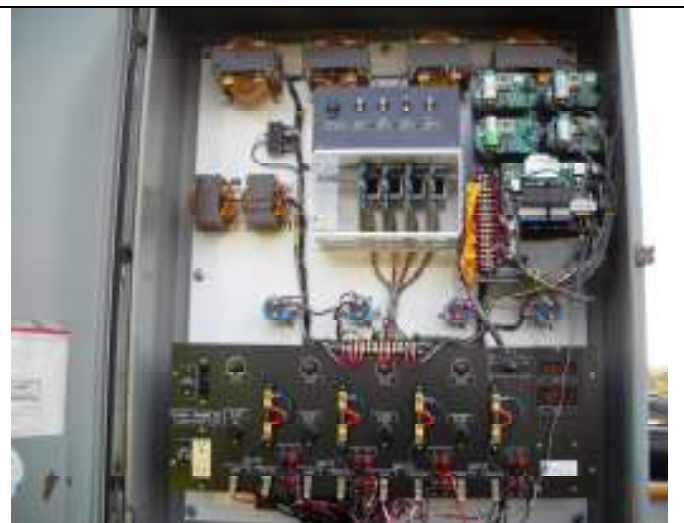
Figure 2: Photo of rectifier enclosure with monitor system installed in upper right side.

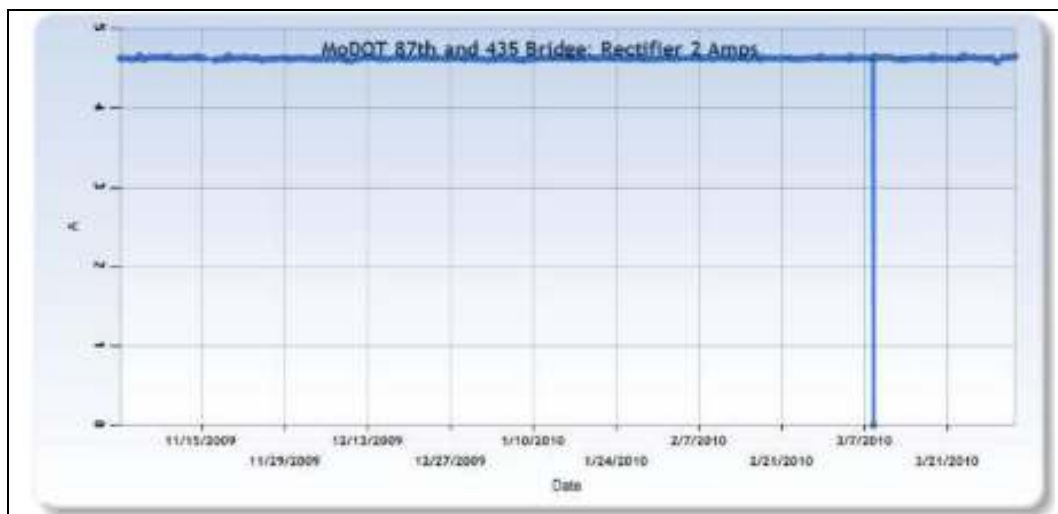
Figure 3: Zone 2 rectifier current output readings from November 2009 through March 2010.

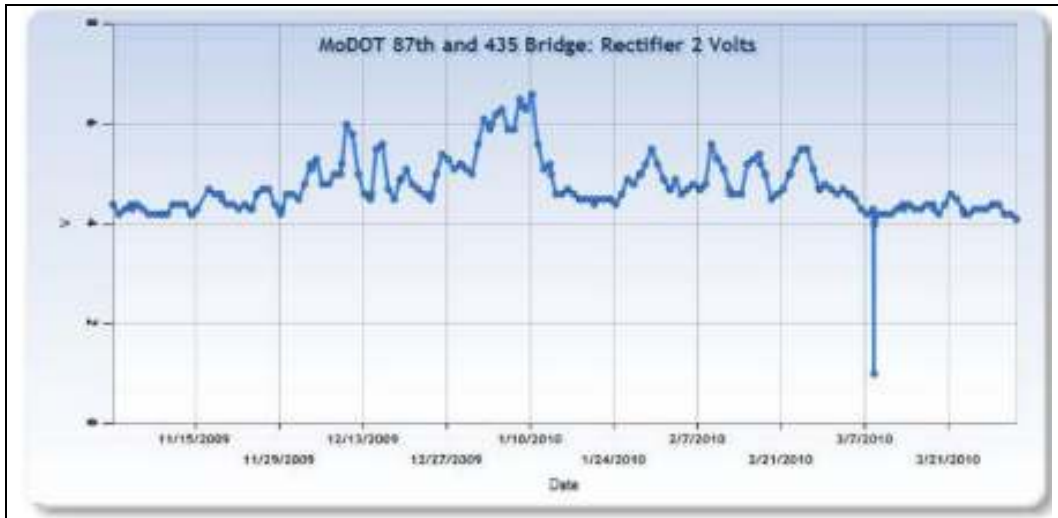
Figure 4: Zone 2 rectifier voltage output readings from November 2009 through March 2010.

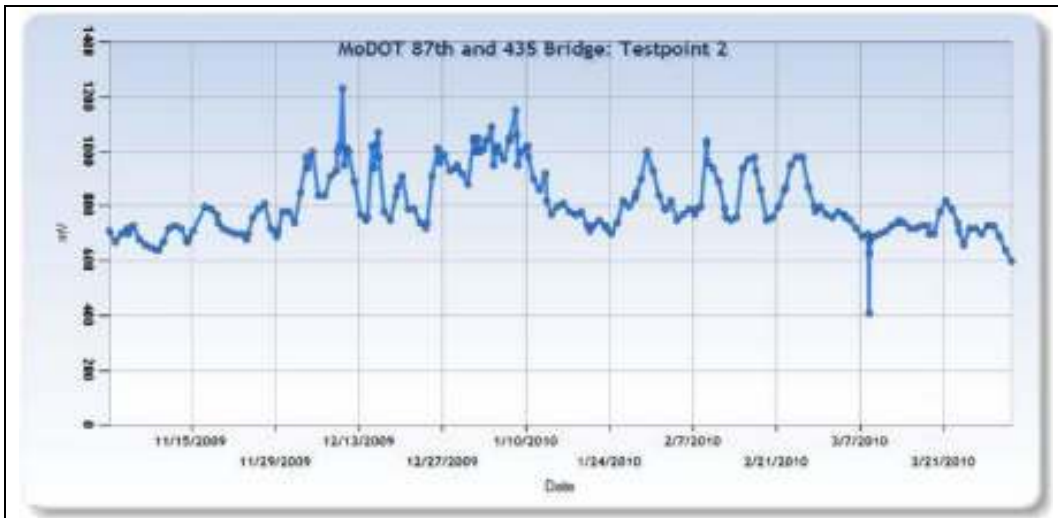
Figure 5: Zone 2 rectifier potential readings from November 2009 through March 2010.

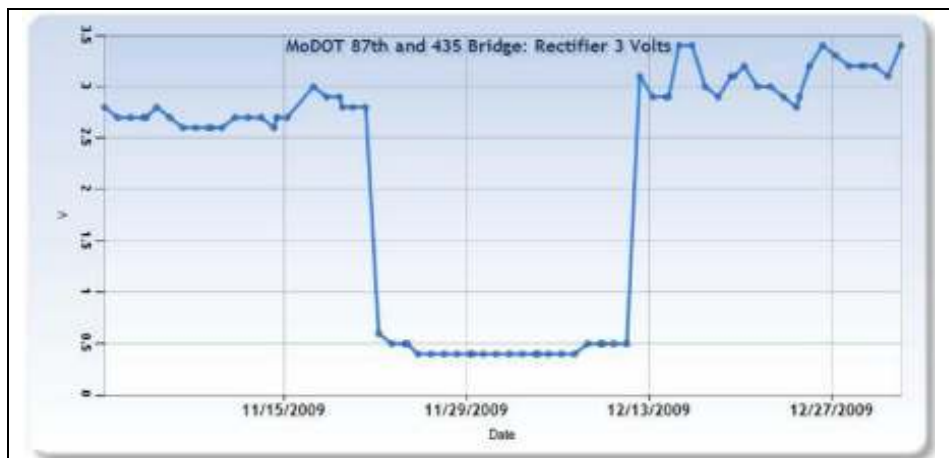
Figure 6: Graph of Zone 3 rectifier voltage output data points showing failure from November 22, 2009 to December 12, 2009

The data history also provided a detailed view of rectifier outages and duration as shown in Figures 6, 7 and 8. These figures illustrate a period of rectifier failure in Zone 3 from November 22, 2009 to December 12, 2009. Notification of the system failure was sent to the engineer when the alarm occurred and re-transmitted periodically as an alarm notification throughout the time span the rectifier was inoperable. In the state where this case study occurred, inspections of the systems every two months are suggested, but the only mandatory inspection is done annually. Section 774.5.1 of the Engineering Policy Guidelines² covering the inspection and maintenance procedures of cathodic protection systems for this organization require that only the "Spring Evaluation" forms be forwarded to the Maintenance Division for the purposes of permanent record-keeping. This requirement may vary from state to state. Prior to the installation of this monitoring system, an event such as this could go unreported for 12 months and still be technically compliant with the data reporting guidelines established for the cathodic protection systems in the state.

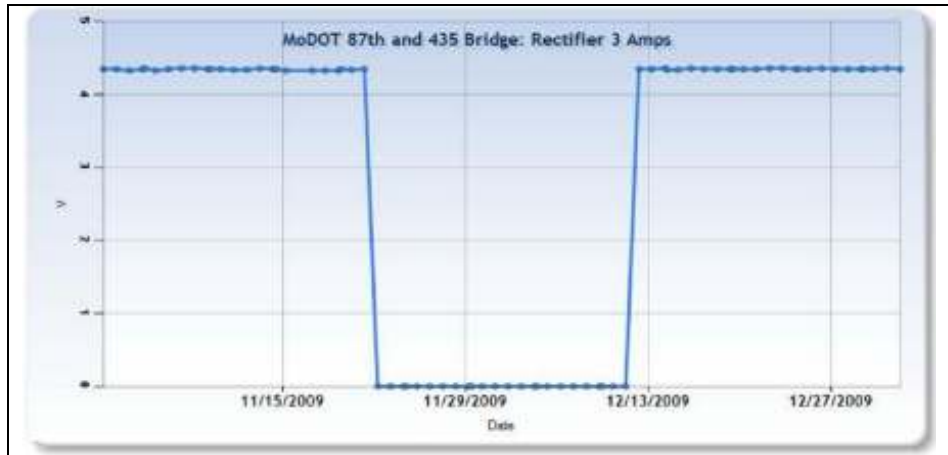
Figure 7: Graph of Zone 3 rectifier current output data points showing failure from November 22, 2009 to December 12, 2009.

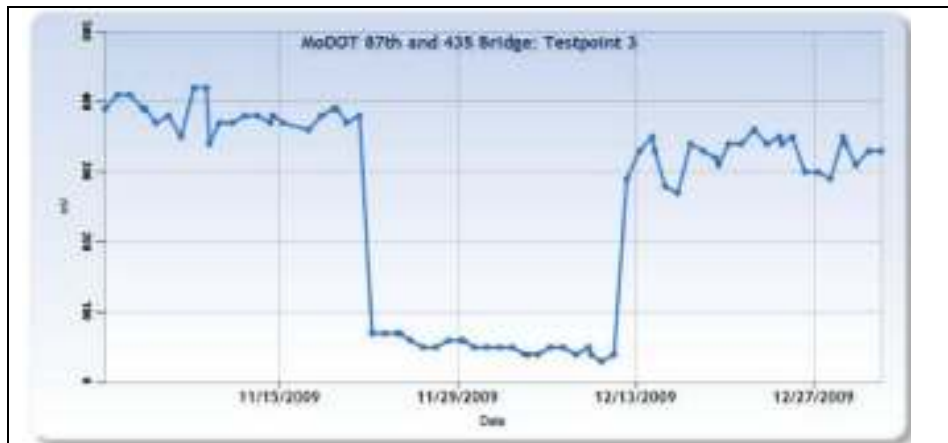
Figure 8: Graph of Zone 3 potential data points showing failure from November 22, 2009 to December 12, 2009

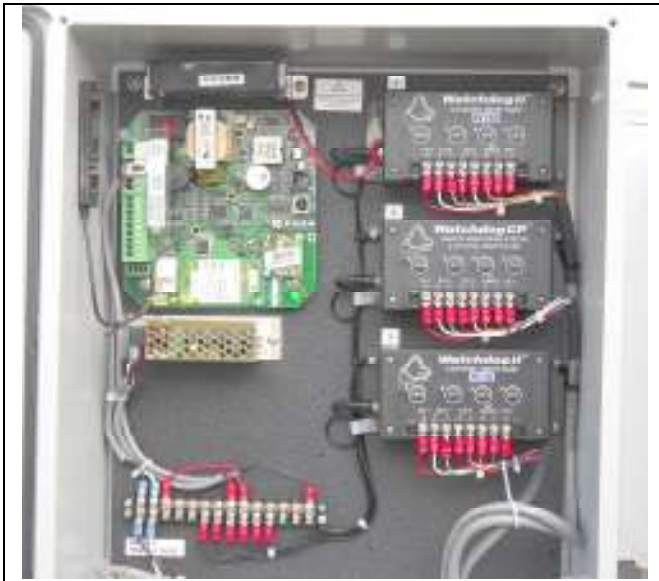
Figure 9: Interior view of a 3-Zone integrated enclosure.

three channel module capable of reporting voltage, current, and potential for that zone, identification of the measurement block associated with each zone at a site was also simplified. All of the systems under consideration for monitoring range from 3 zones to 10 zones. This design change enabled any site in the system to be fully monitored with a minimum of two systems, meeting a primary objective of minimizing monthly communication costs. The 5-year lithium battery power for the analog measurement modules was reevaluated as well. The integrated enclosures were designed with a 110V power supply capable of supplying operational voltage to the base station and the analog modules in each enclosure, eliminating the non-rechargeable lithium cells. Figures 9 and 10 below show the enclosures installed at a six zone rectifier site.

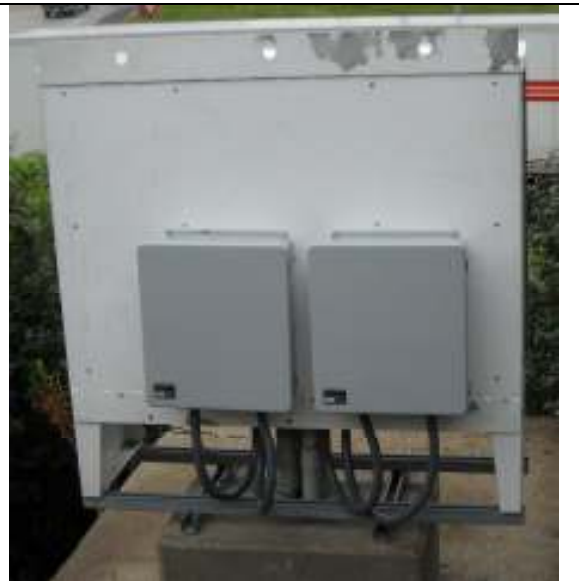
Figure 10: Two 3-Zone enclosures mounted at a six zone rectifier site.
