## **Corrosion Rate Monitoring in Pipeline Casings**

Jamey Hilleary  
Elecsys Corporation  
846 North Mart-Way Ct.  
Olathe, KS, 66061  
USA

Jerry DeWitt  
Enbridge Energy Partners  
1500 West Main St.  
Griffith, IN 46319  
USA

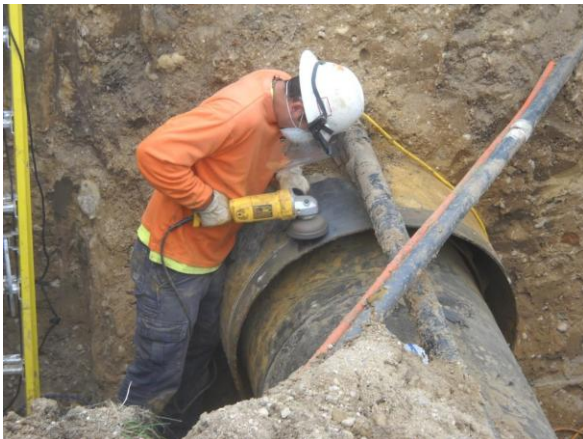
**Figure 1: Cleaning the casing and pipe**

The carrier pipe at this site was a 30 inch (762 mm) coated steel pipeline transporting crude oil. The casing at the site was approximately 38 inches (965 mm) in diameter and located approximately five feet (1.2 m) beneath a two-lane highway. The sites selected for this study were evaluated for casing and carrier pipe integrity. The first steps were to excavate the pipe and casing in order to replace the boot with new sealant compound and secure wrapping in order to completely seal the casing ends (Figures 1 - 4).

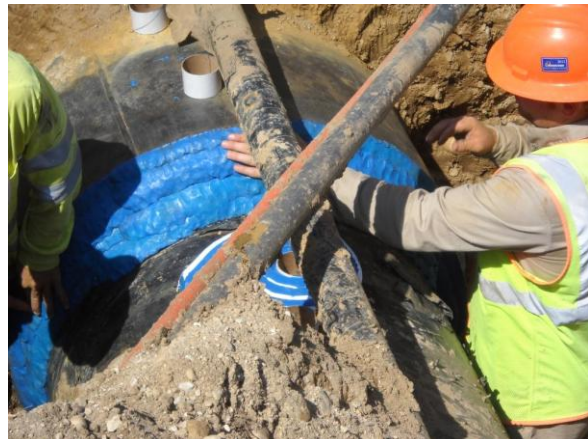
**Figure 2: Sealing compound is installed between carrier pipe and casing.**

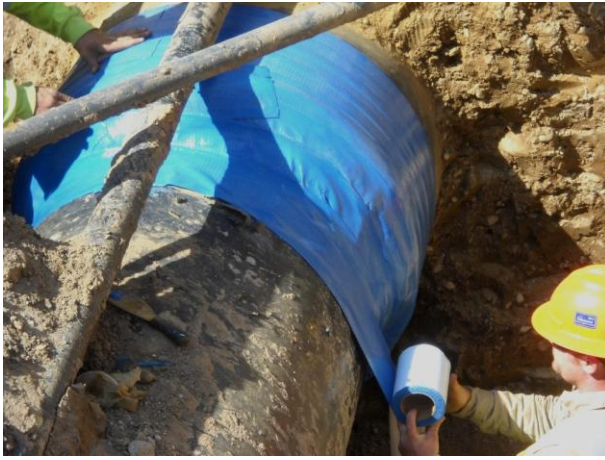
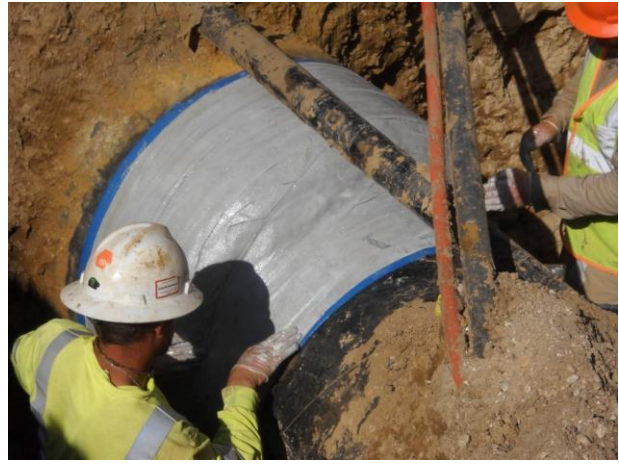
**Figure 3: Adhesive wrapping applied over seal. Figure 4: Hardening overwrap applied.**

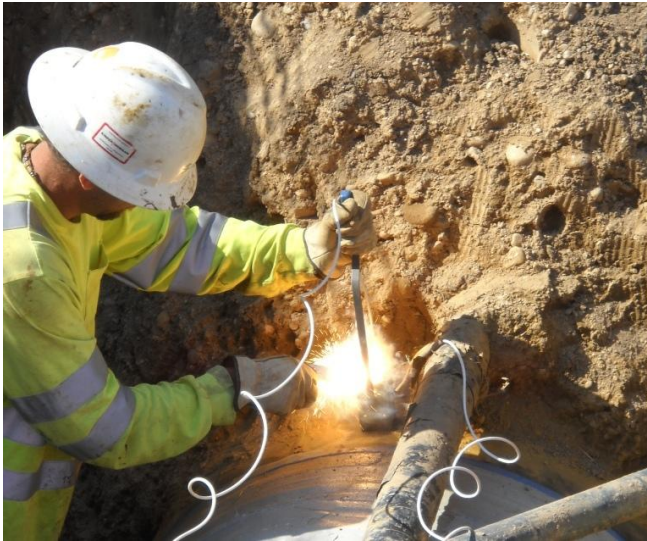
**Figure 5: Welding leads to the casing.**

Following rehabilitation of the casing seal, leads were attached to the casing and to the carrier pipe, and a reference cell was installed adjacent to the pipe in order to measure pipe to soil potentials on the unprotected casing and the protected carrier pipe (Figure 5 and Figure 6).

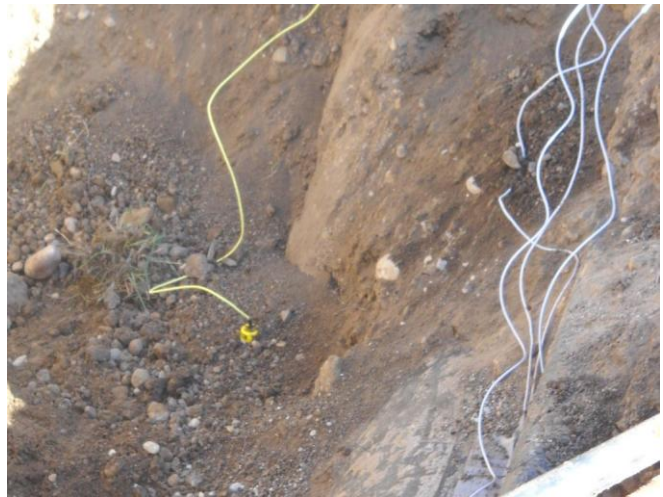
**Figure 6: Installing the reference cell.**

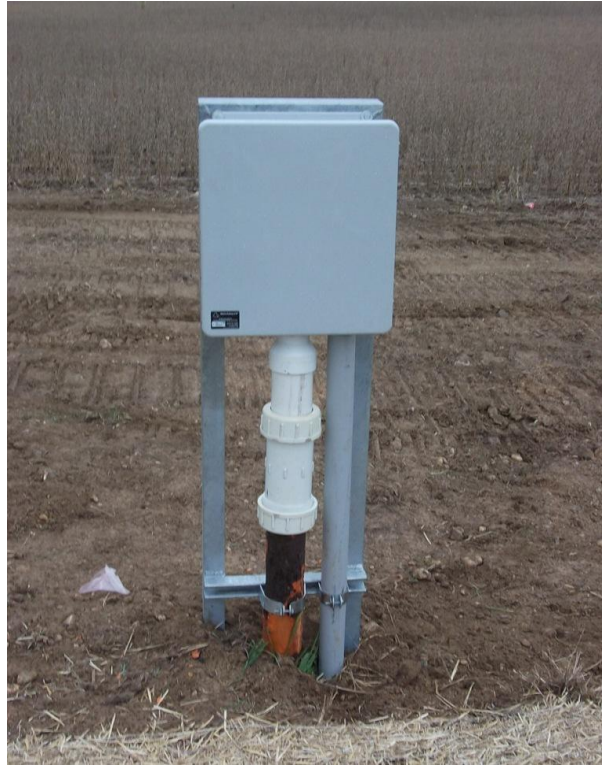
**Figure 7: Photo of monitor equipment installed.**

The excavation was refilled and the ER probe and monitor system were installed. The ER probe was suspended in the upper portion of the casing, above the carrier pipe. The ER probe leads, casing structure lead, carrier pipe lead, and reference cell lead were all connected to the terminals at the remote monitor. The monitor unit was located atop the vent pipe and the vent pipe was sealed with a cord-grip insert allowing the lead cables to pass through to the monitor connection terminals while maintaining the vapor phase atmosphere in the annular space (Figure 7).

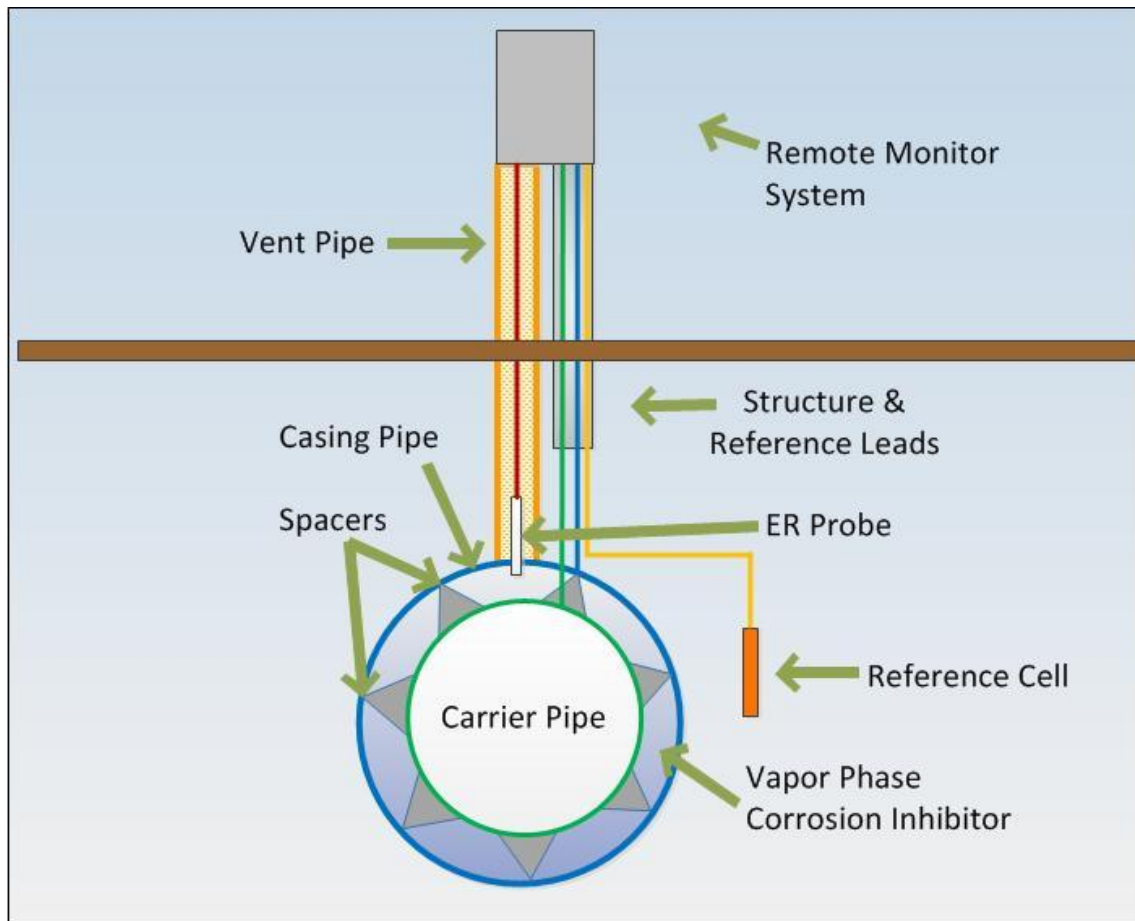
**Figure 8 – Diagram of completed project site**

Following the completion of the casing seal rehabilitation, and the installation of the monitoring equipment, the annular space inside the casing was partially filled with an atomized liquid VpCI product. The corrosion inhibitor molecules in this solution can mix with and migrate through water, soil, and vapor space inside the casing. If the casing is well-sealed, the corrosion inhibitor does not need to fill the entire annular space in order to remain effective. This characteristic allows the use of the ER probe in the unfilled upper portion of the annular space in order to determine the corrosion rate in the annular space on a continual basis (Figure 8).

Following the application of the corrosion inhibitor into the casing, the “fill vent pipe” was fitted with a pressure release/vacuum breaker valve in order to maintain the vapor phase environment throughout the annular space.

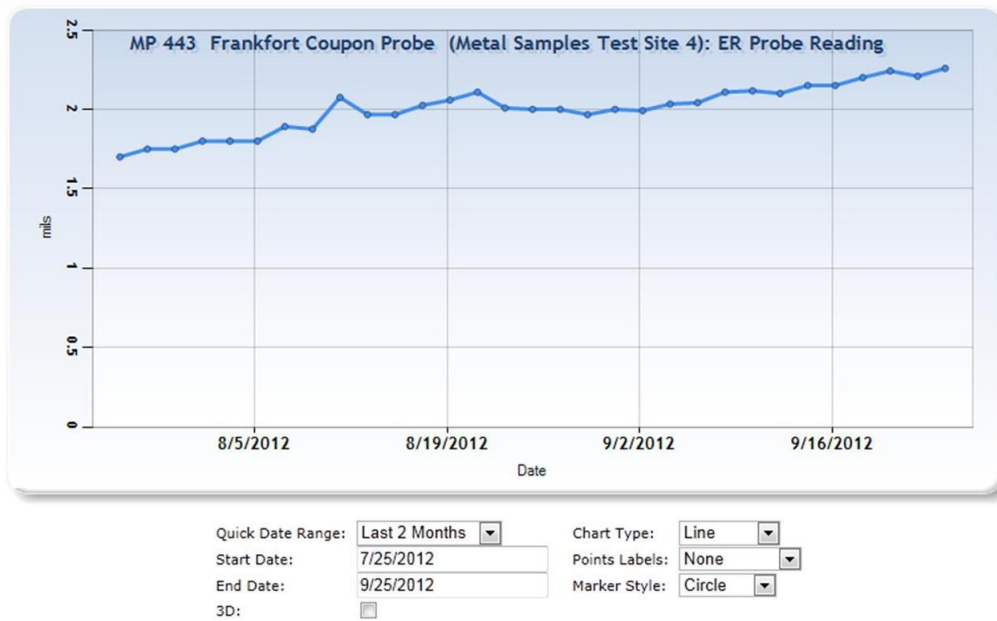
**Figure 9 – Graphical display of corrosion rate in mils per year from test site (screen shot).**

If leaks in the casing develop, the corrosion rate reported by the probe will significantly change, thereby alerting the operator to a potential corrosive environment inside the casing. Steps can be taken, from refilling the casing with additional inhibitor to complete rehabilitation of the casing if necessary, to remedy the issue. The corrosion rate measured by the probe is transmitted to the remote monitor web interface. On the website the raw data (resistance value) measured at the probe is converted into a “mils per year” corrosion rate. This data is stored on the website and can be displayed graphically showing a corrosion rate trend (Figure 9). Changes in that trend line can be evaluated periodically for significance.

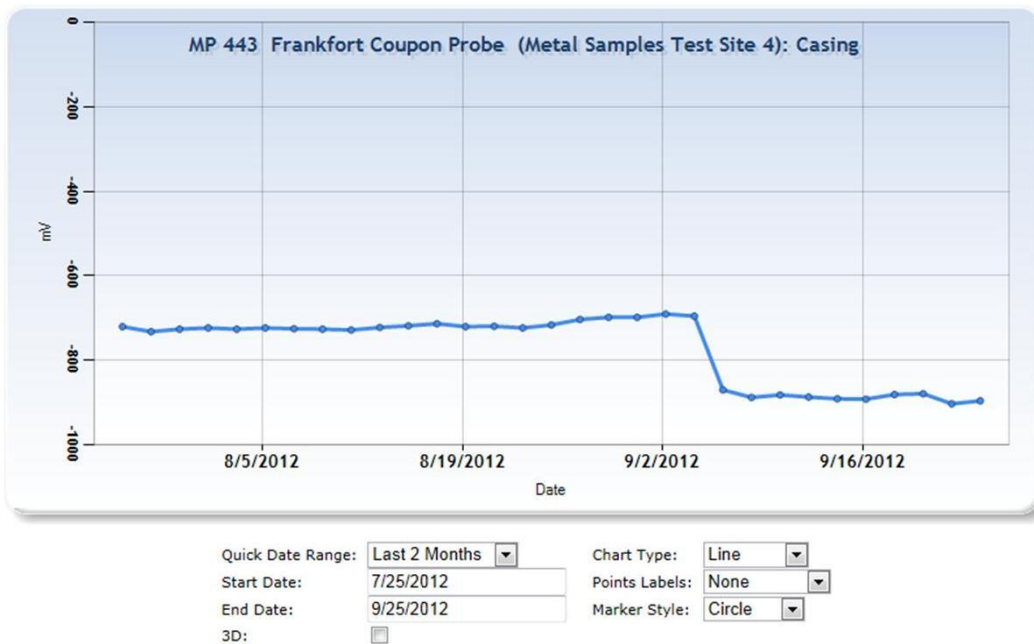
**Figure 10 – Casing potential measurements (note “event” on 9/5/12).**

The monitor system was also recording structure to soil potential readings for the casing and the carrier pipe at the same intervals as the corrosion rate data. These measurements were transmitted to the web interface as well. The voltage potential measurements provide information regarding the level of protection on the carrier pipe and can also indicate a casing to carrier pipe short condition as shown in the screen shots below (Figures 10 and 11). The “normal” potential on the casing was in the -720mV range until 9/5/12. The “normal” potential on the carrier pipe was in the range of -1250mV until 9/5/12. The potential measurements for both the casing and carrier pipes shifted to -890mV when it reported on 9/5. This event is consistent with the carrier pipe shorting to the unprotected casing, and the casing in turn becoming a ground for the cathodic protection current.

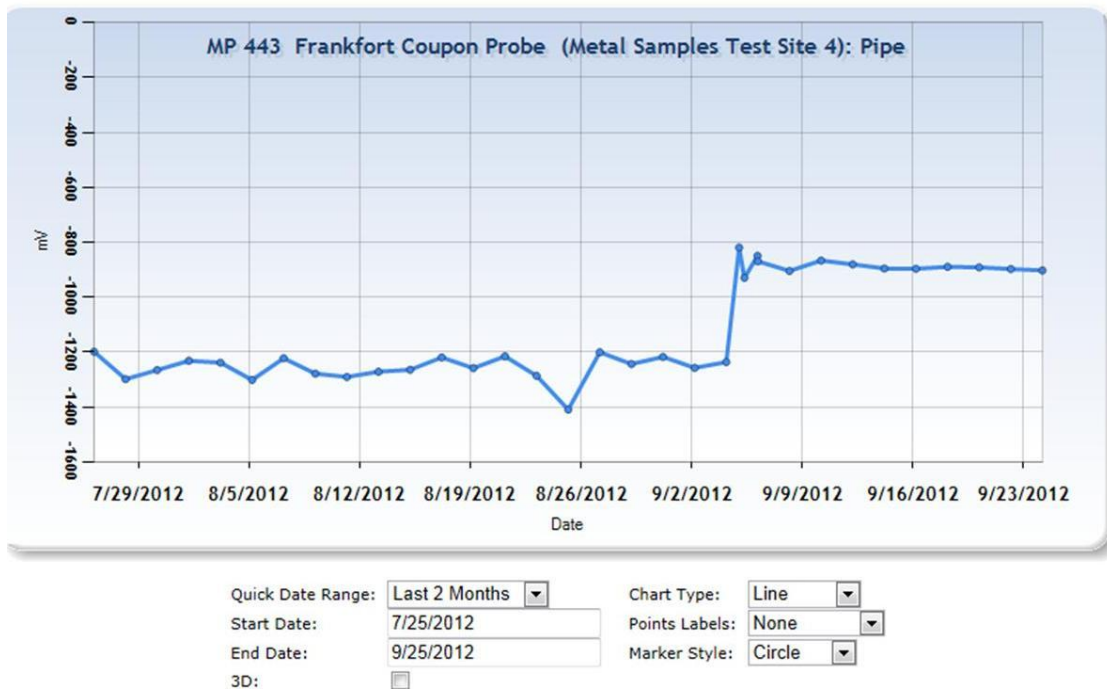
**Figure 11 – Carrier pipe potential measurements (note “event” on 9/5/12)**
